AMZS d.o.o.
Cenitve in ostali pregledi vozil
Dunajska 128a
1000 Ljubljana

CENILNO POROČILO

OSEBNI AVTOMOBIL (M1)
VOLKSWAGEN ARTEON 2.0 TSI 4M AUT
VIN: **WVWZZZ3HZNE504776**

Ljubljana, 16.03.2026

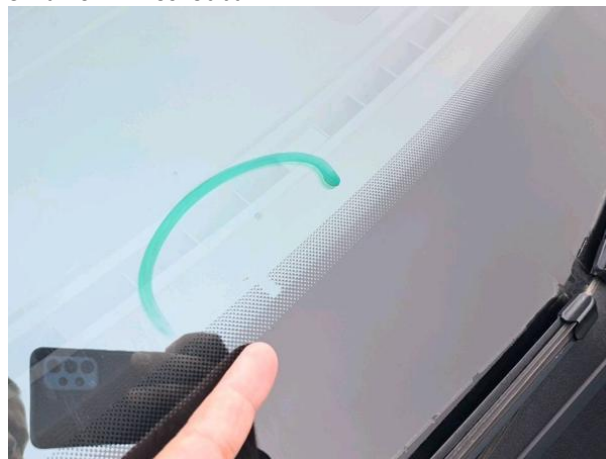
Slika R01-1: Poškodba

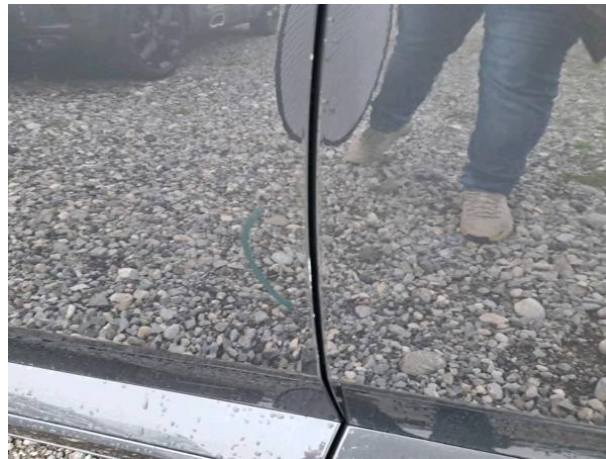
Slika R02-1: Poškodba

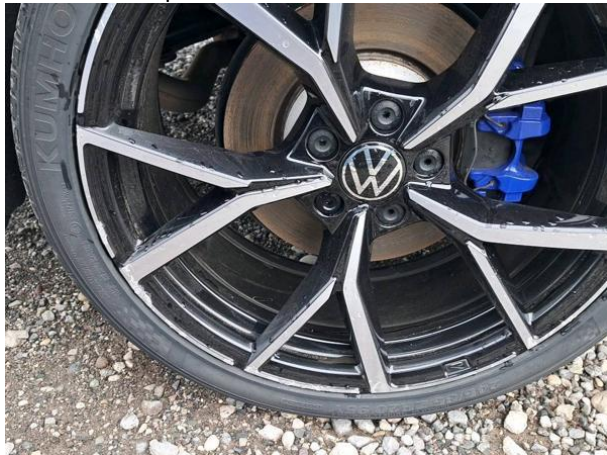
Slika R03-1: Popraskano

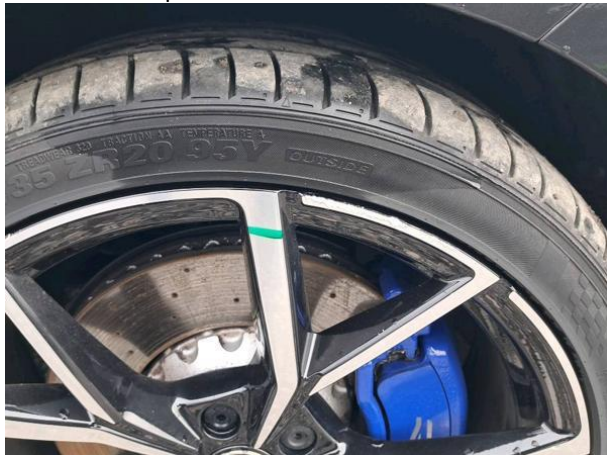
Slika R04-1: Popraskano

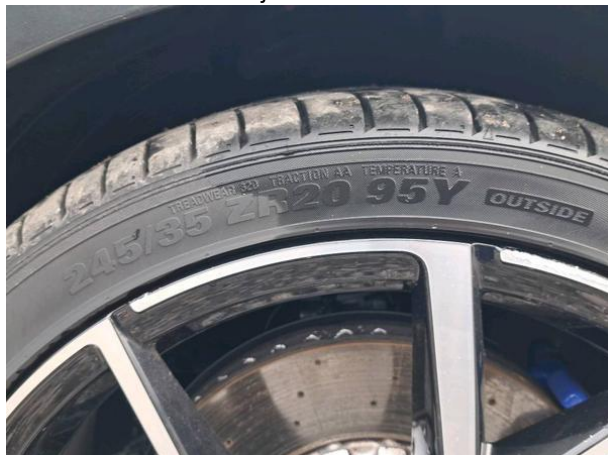
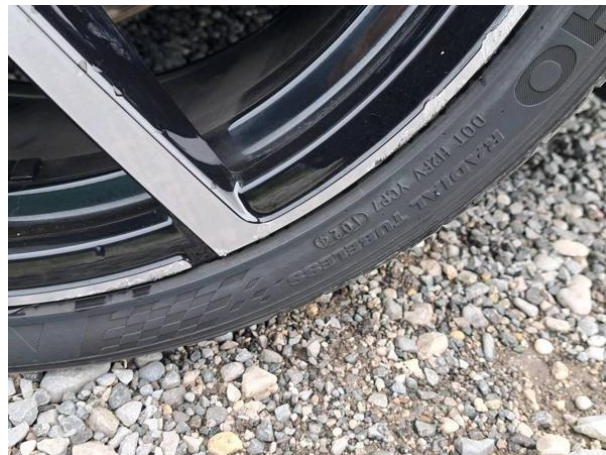
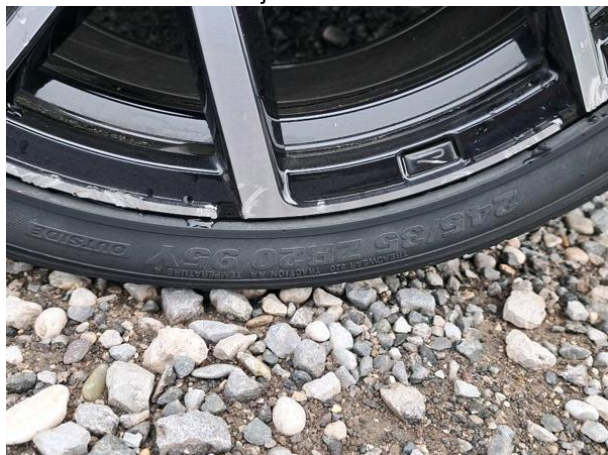
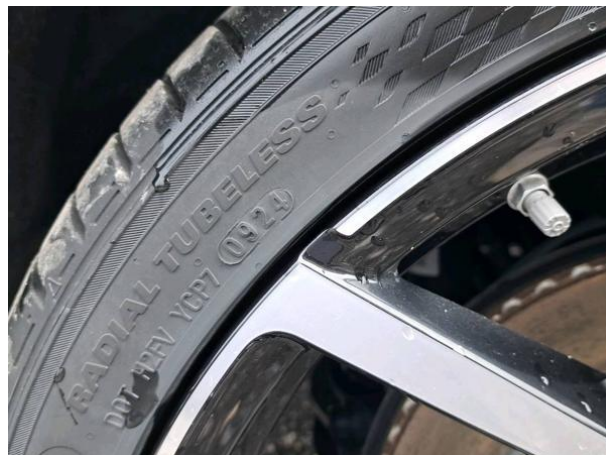
Pnevmatike so dimenzijsko ustrezne, starostno primerne in z dovolj profila.
Opozorilo za prenizek tlak v pnevmatikah.

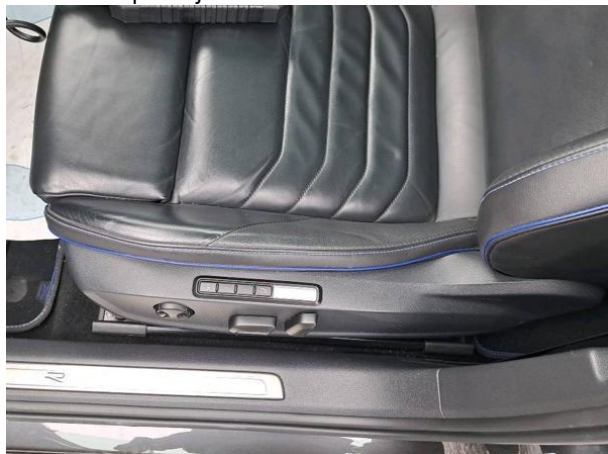
Slika N05: Sprednji levi sedež

- Sprednji levi sedež - poškodba

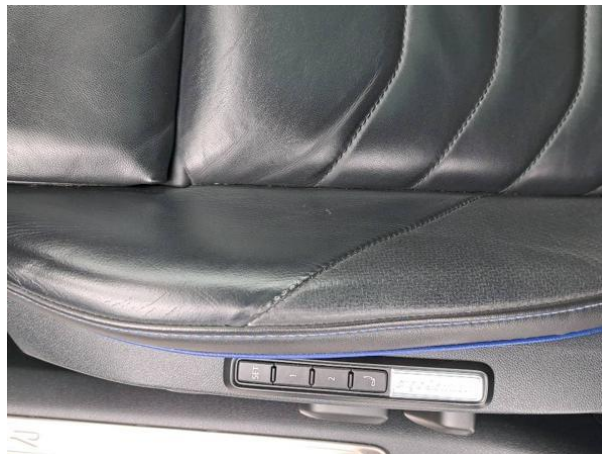
Slika N05-1: Poškodba
