CENILNO POROČILO

OSEBNI AVTOMOBIL (M1)
VOLVO XC 60 / 2.0 / TD AUT. AWD
VIN: YV1UZA8BCJ1003740

Ljubljana, 16.02.2026

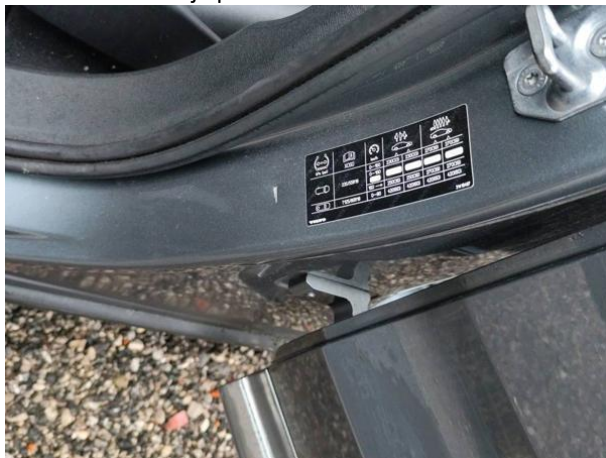
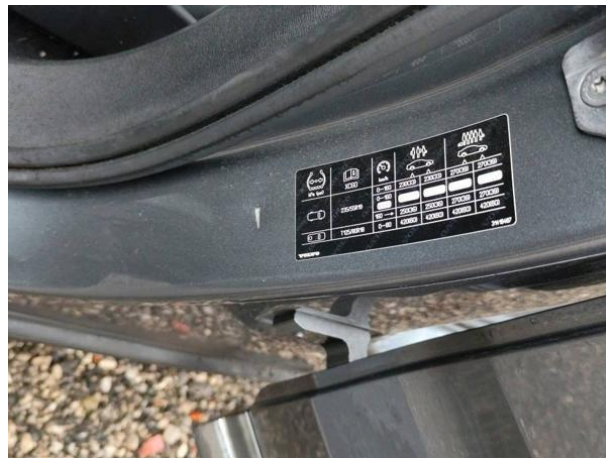
Slika R01: Notranja pločevina

Slika R01-1: Poškodba

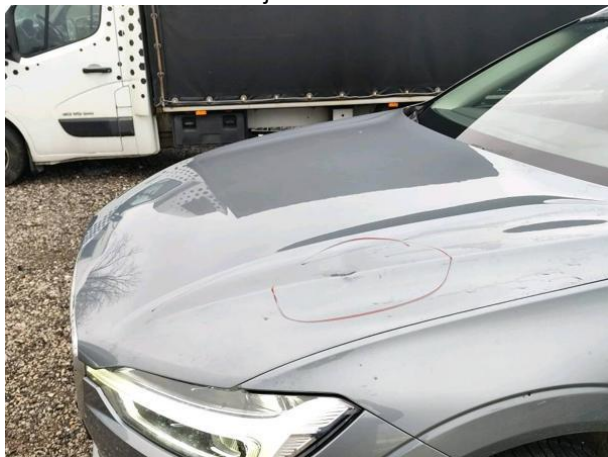
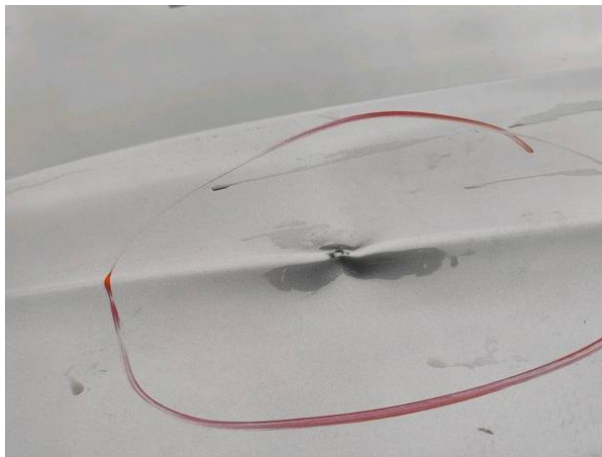
Slika R02: Pokrov motorja

Slika R02-1: Poškodba

- pokrov motorja

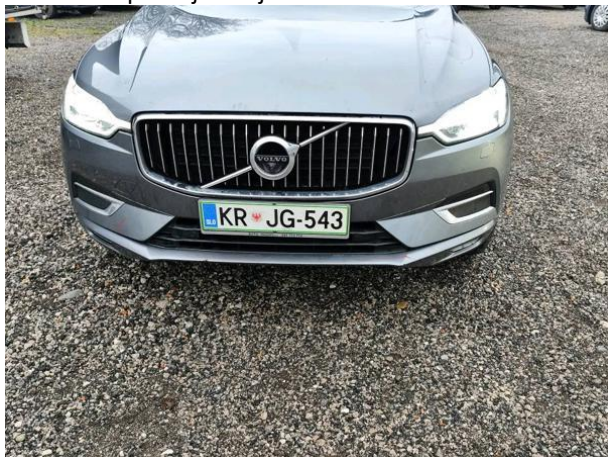
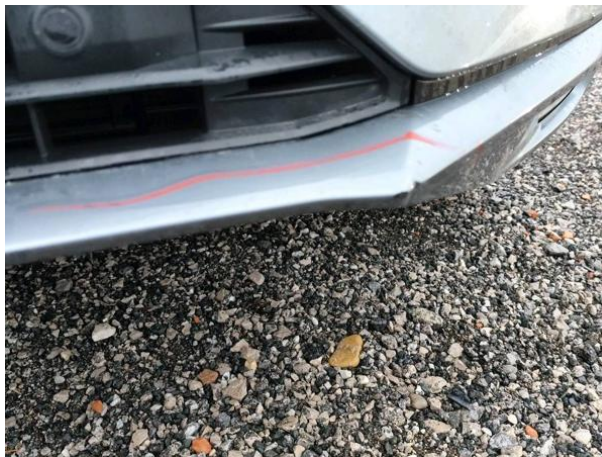
Slika R03: Sprednji odbijač

Slika R03-1: Poškodba

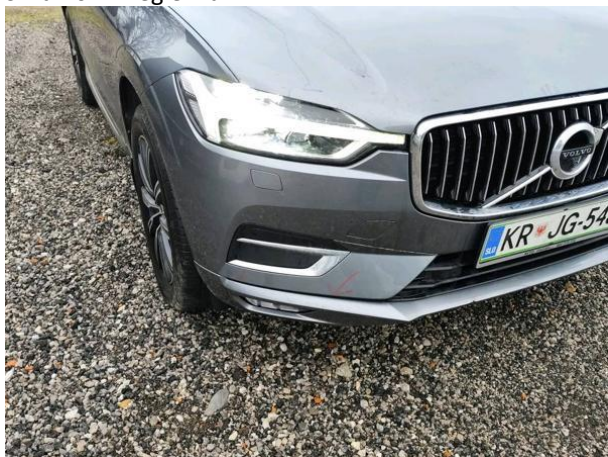
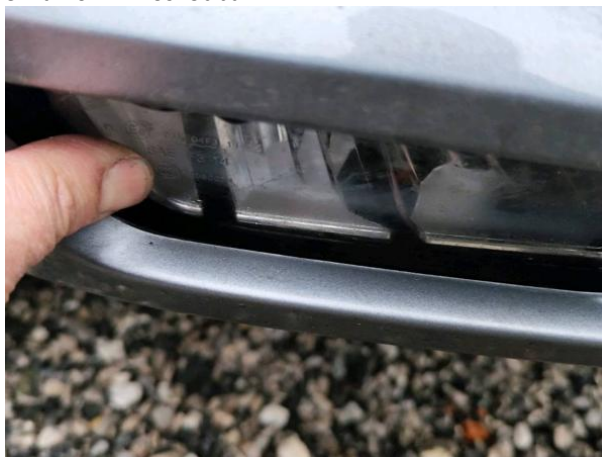
Slika R04: Meglenka

Slika R04-1: Poškodba

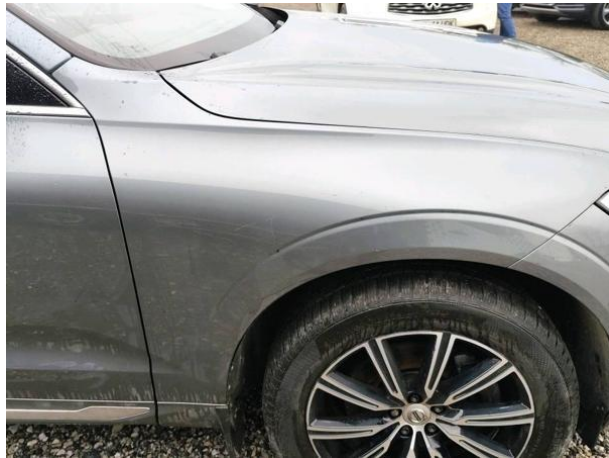
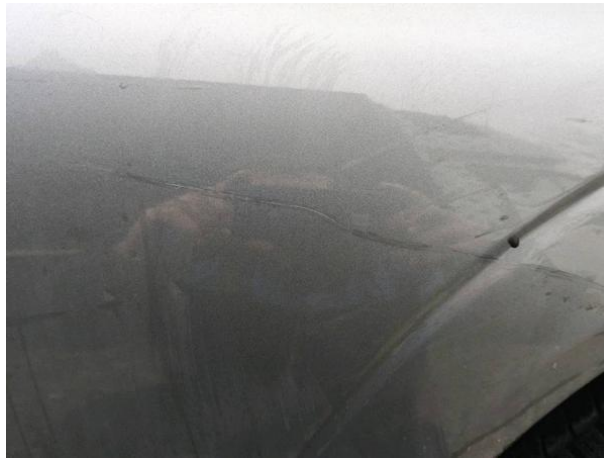
Slika R05: Blatnik desni

Slika R05-1: Poškodba laka

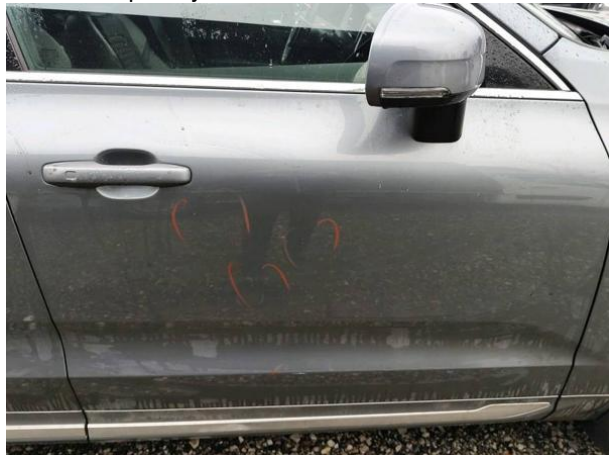
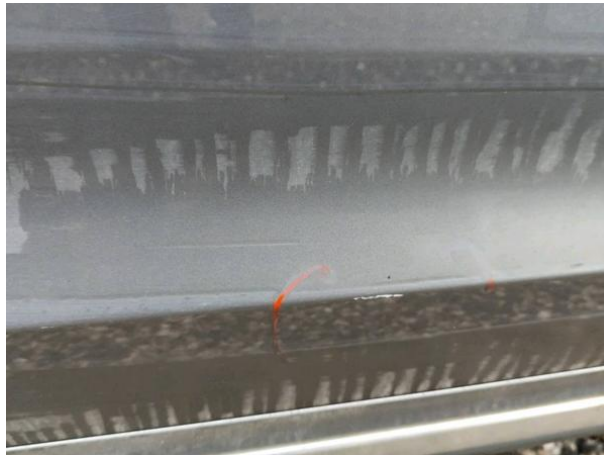
Slika R06: Sprednja vrata desna

Slika R06-1: Poškodba laka

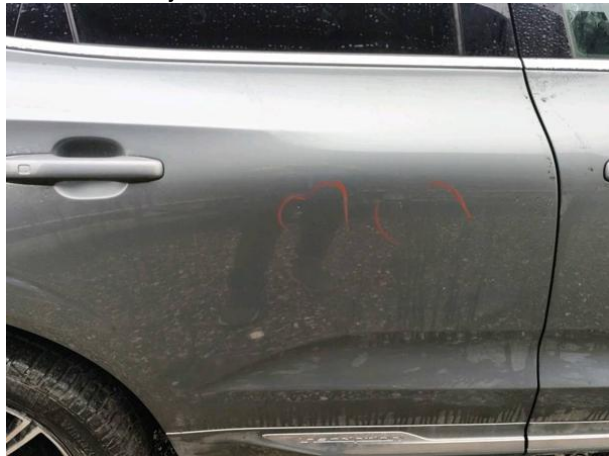
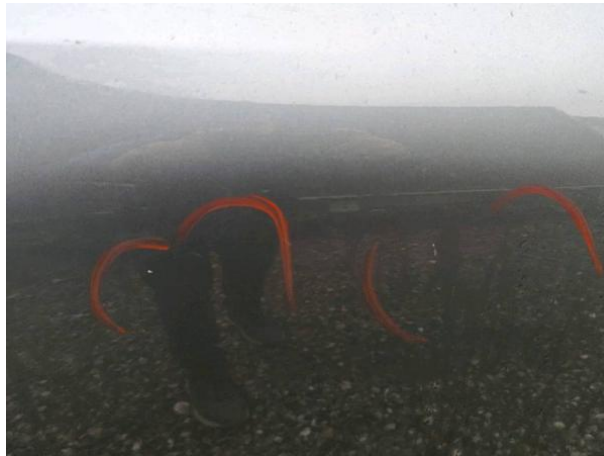
Slika R07: Zadnja vrata desna

Slika R07-1: Poškodba laka

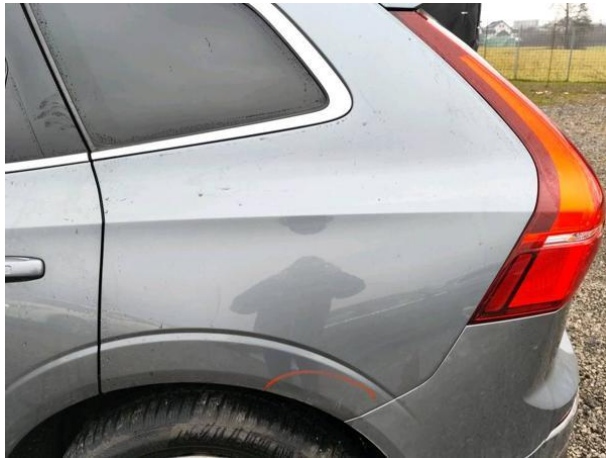
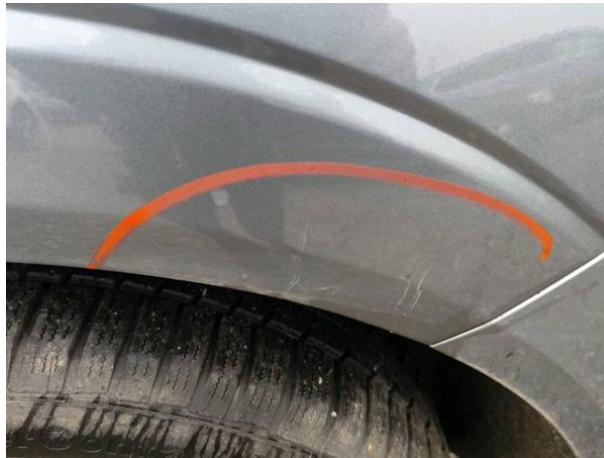
Slika R08: Stranica leva

Slika R08-1: Poškodba laka

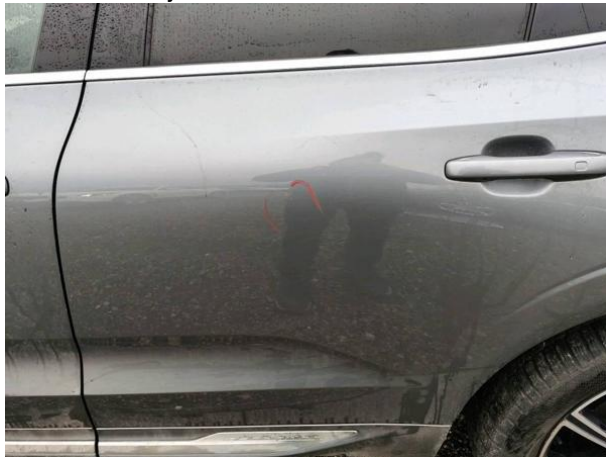
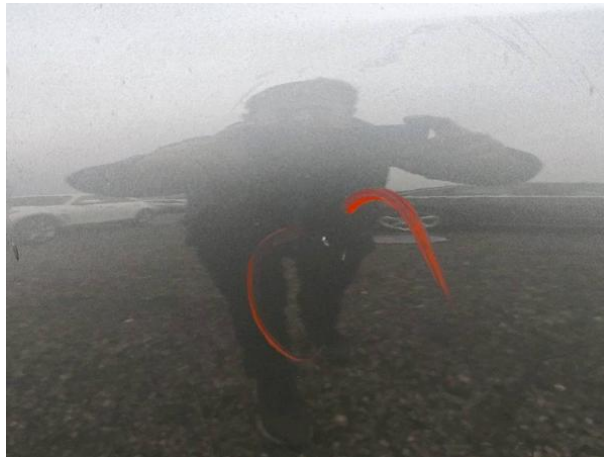
Slika R09: Zadnja vrata leva

Slika R09-1: Poškodba laka

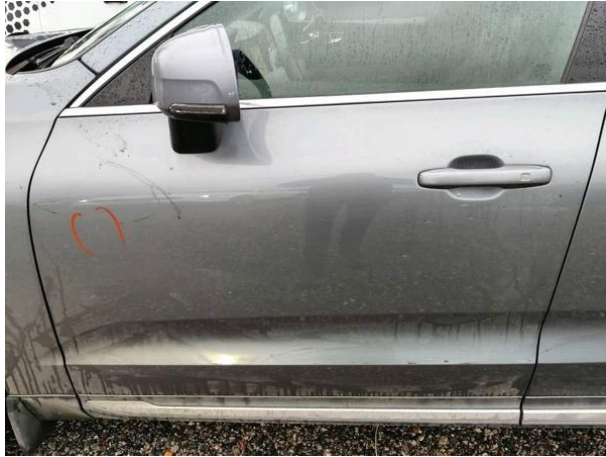
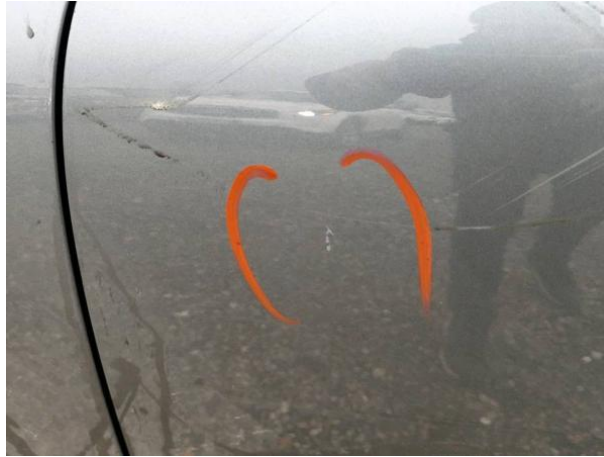
Slika R10: Sprednja vrata leva

Slika R10-1: Poškodba laka

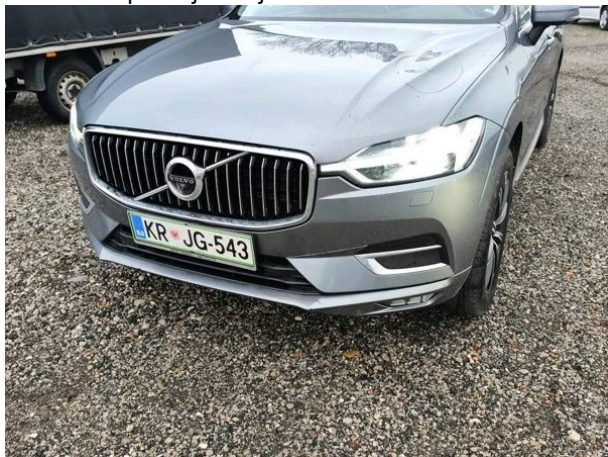
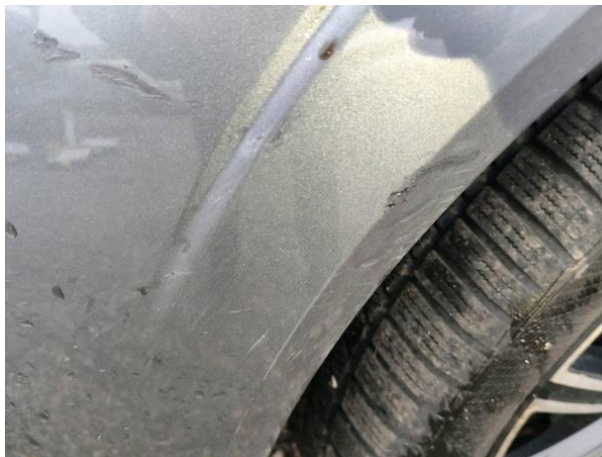
Slika R11: Sprednji odbijač

Slika R11-1: Poškodba

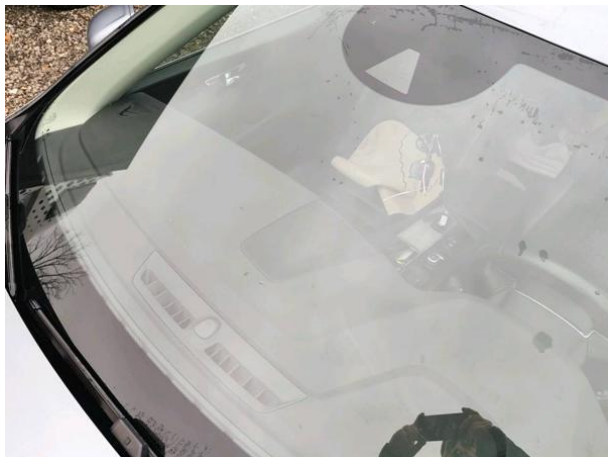
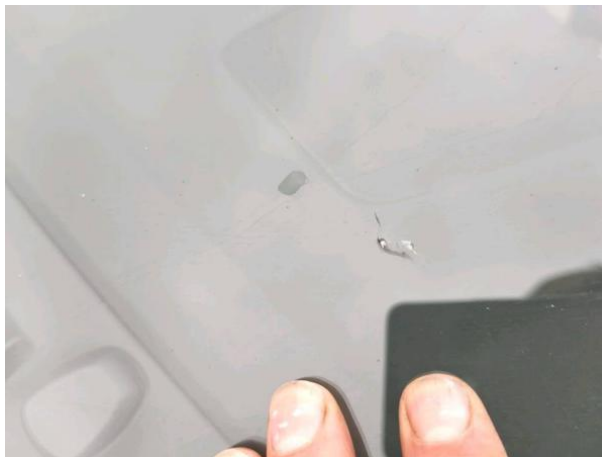
Slika R12: Vetrobransko steklo

Slika R12-1: Poškodba

Poškodovano vetrobransko steklo, ostala stekla in stekla vzvratnih ogledal niso poškodovana.

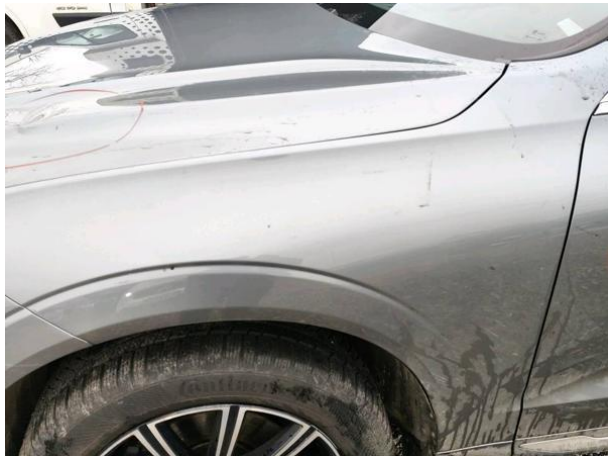
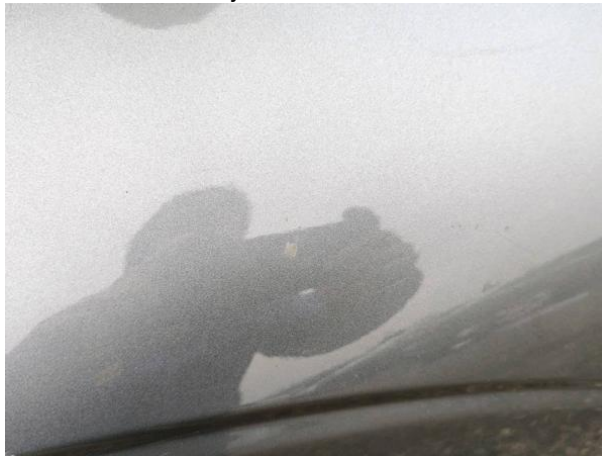
Slika R13: Blatnik levi

Slika R13-1: Umazanija

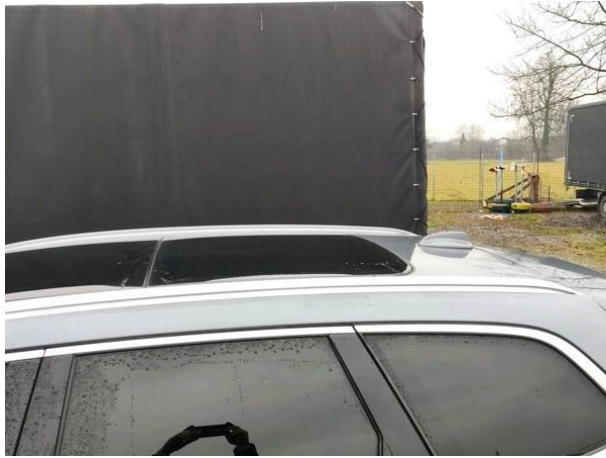
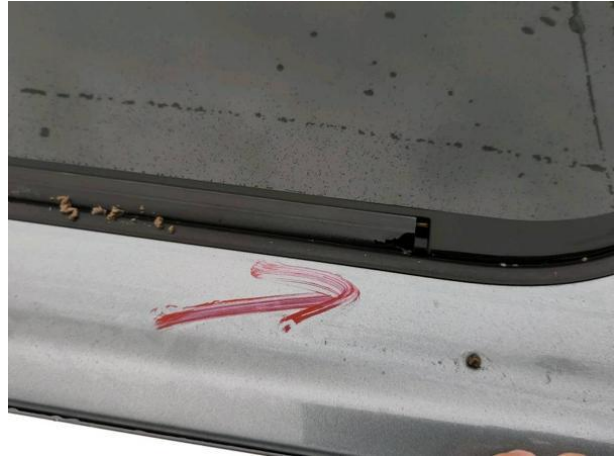
Slika R14: Tesnilo strešnega okna

Slika R14-1: Poškodba

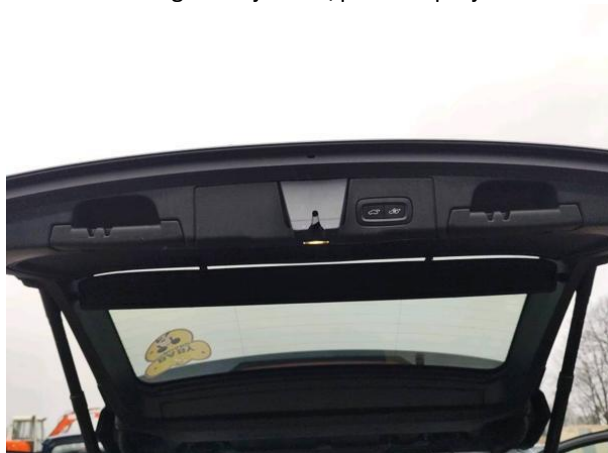
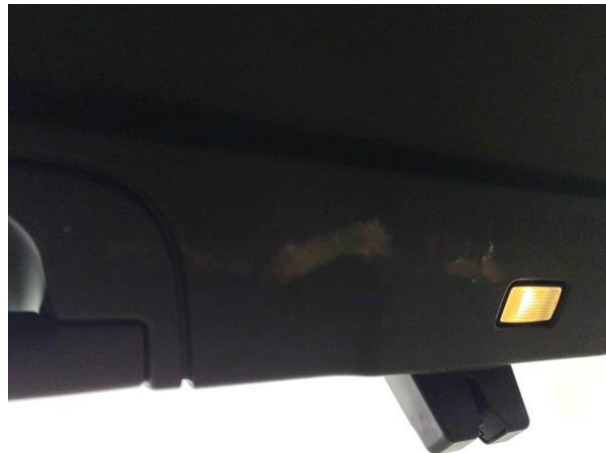
Slika N05: Obloga zadnjih vrat/pokrova prtljažnika

Slika N05-1: Poškodba

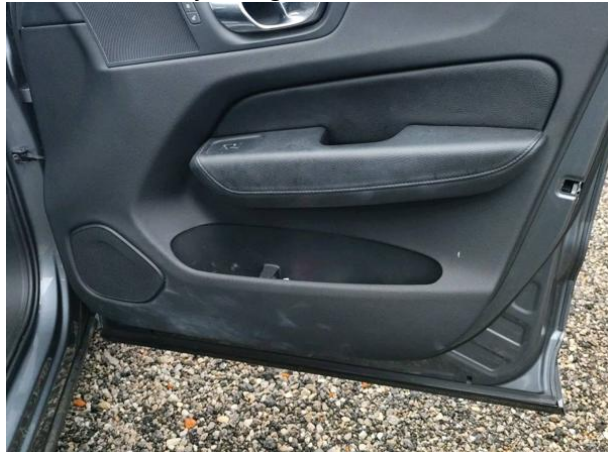
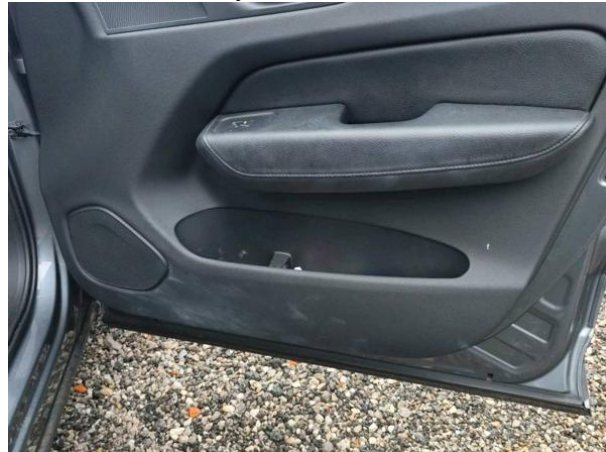
Slika N06: Notranja obloga vrat

Slika N06-1: Umazanija

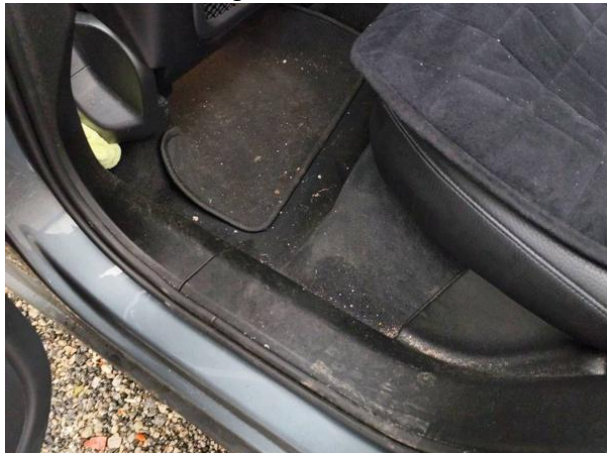
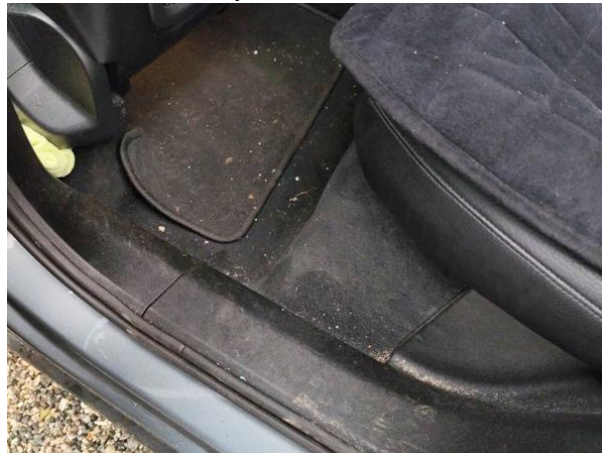
Slika N07: Talna obloga

Slika N07-1: Umazanija

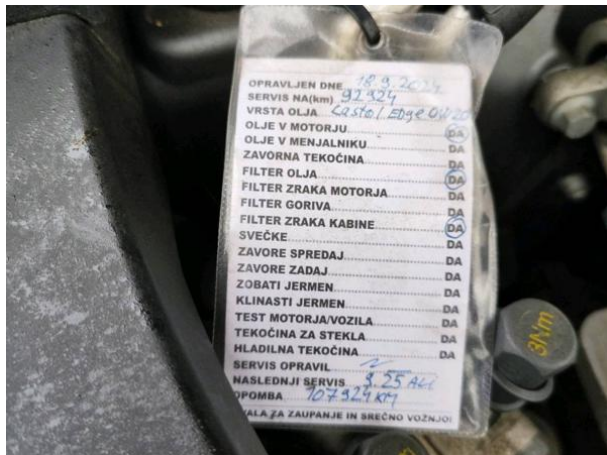
Zadnji servis opravljen 18.09.2024 pri 92924 km, glede na servisni interval **je potrebno opraviti servis.**

Slika M03: servisni listek
