AMZS d.o.o.
Cenitve in ostali pregledi vozil
Dunajska 128a
1000 Ljubljana

CENILNO POROČILO

OSEBNO AVTOMOBIL M1G
MERCEDES BENZ GLE / 300 / d 4-MATIC AUT.
VIN: WDC1671191A060715

Ljubljana, 17.09.2025

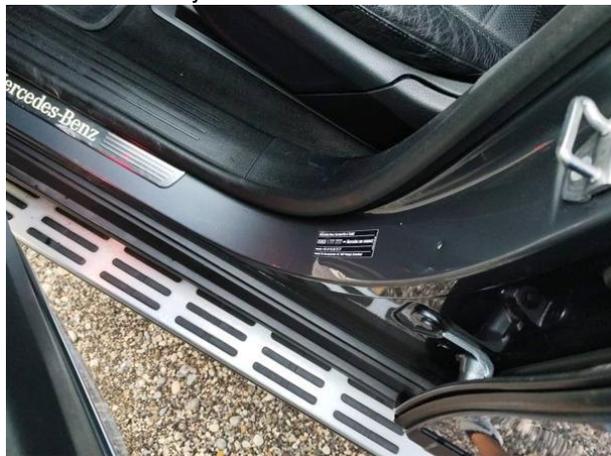
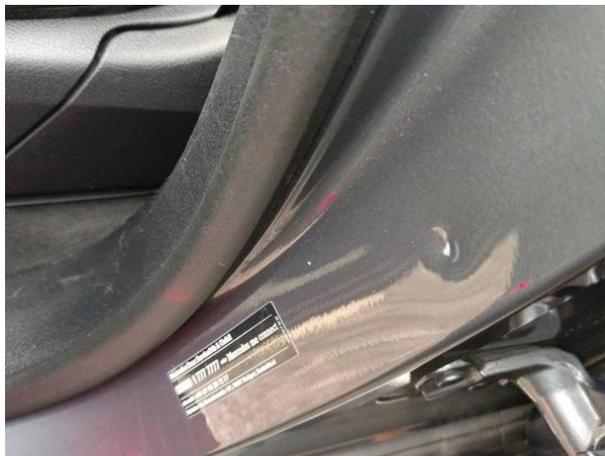
Slika R01: Notranji okvir vrat

Slika R01-1: Poškodba

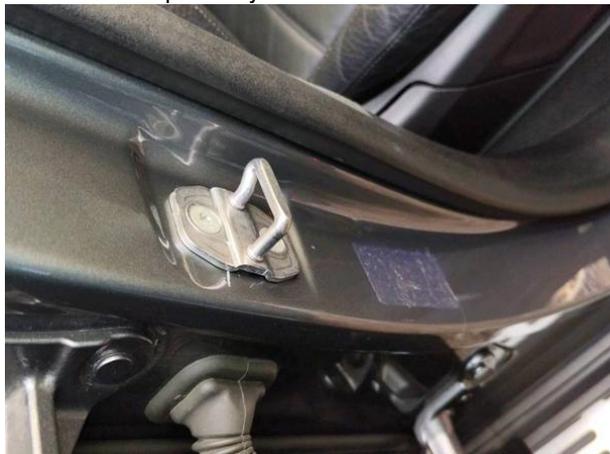
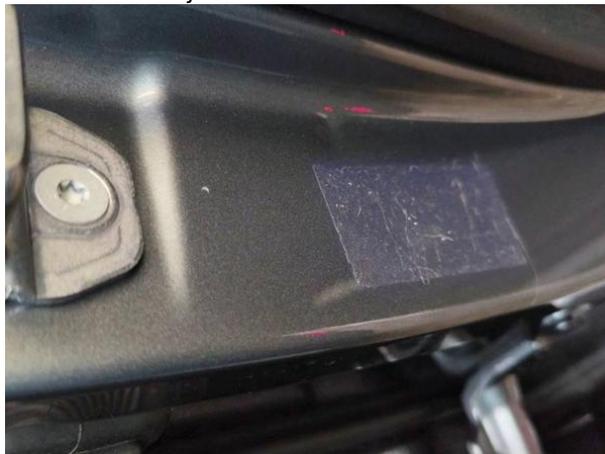
Slika R02: Nalepka šasije

Slika R02-1: Manjka

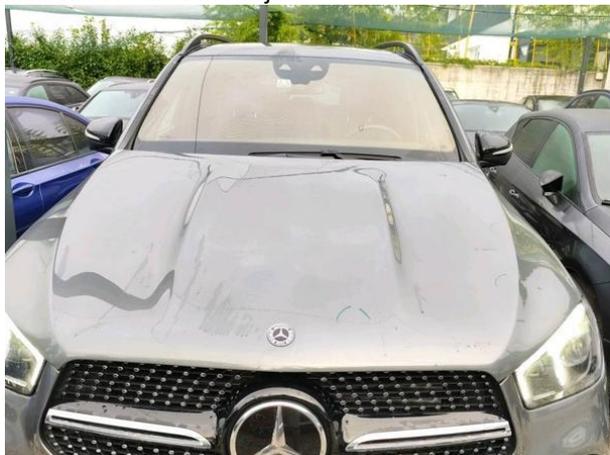
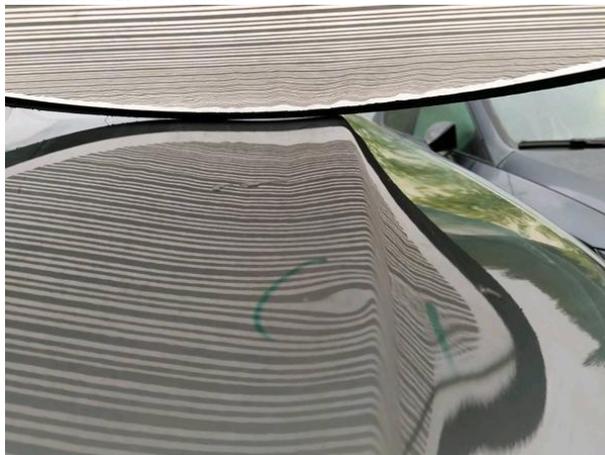
Slika R03: Pokrov motorja

Slika R03-1: Vdolbine

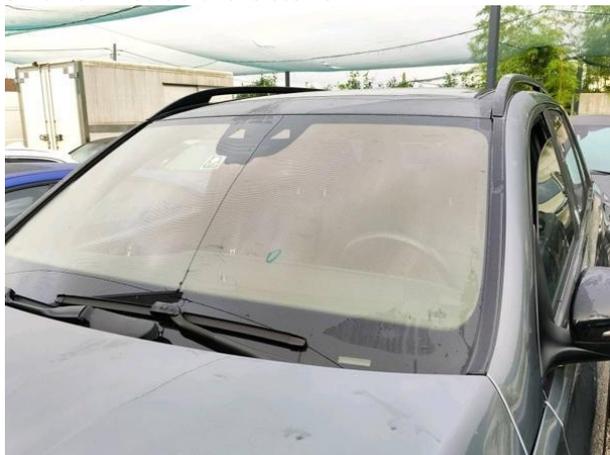
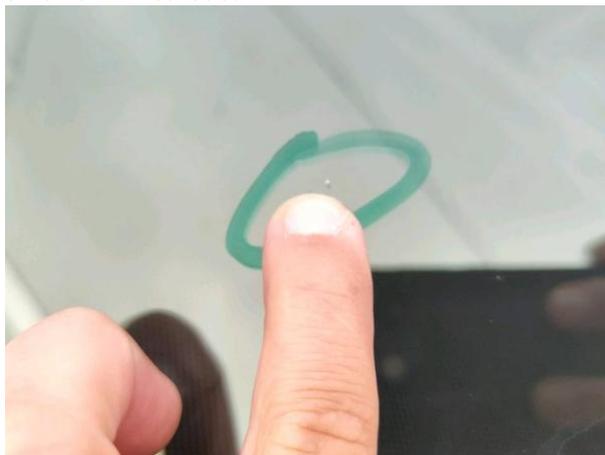
Slika R04: Vetrobransko steklo

Slika R04-1: Poškodba

Vetrobransko steklo lažje poškodovano. Ostala stekla in stekla vzratnih ogledal niso poškodovana.

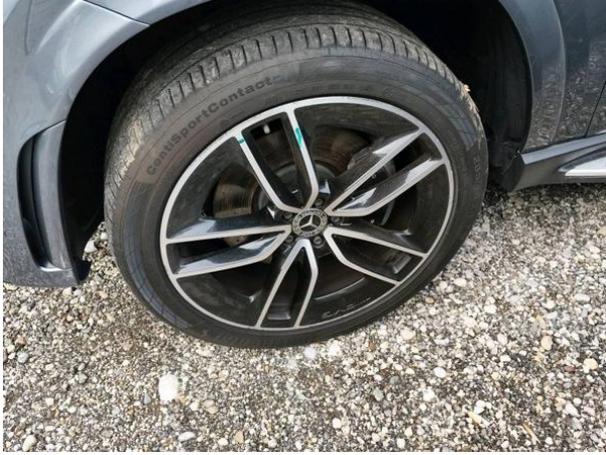
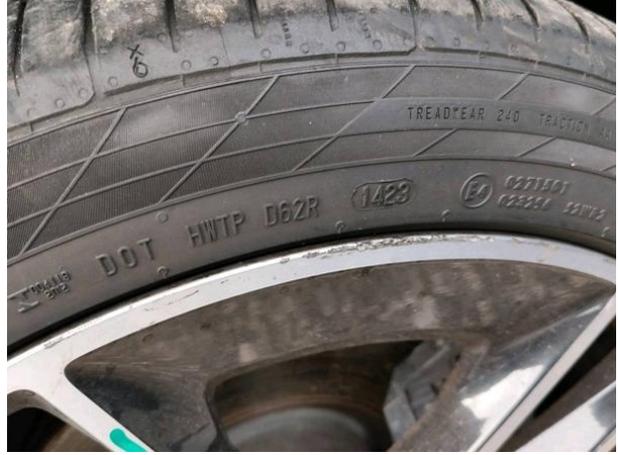
Slika R05: Al platišče

Slika R05-1: Popraskano

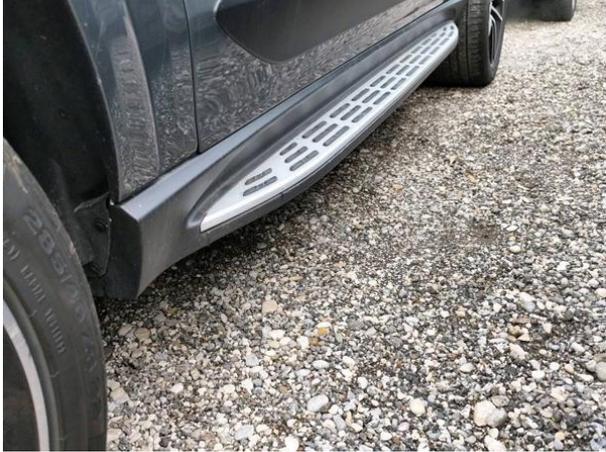
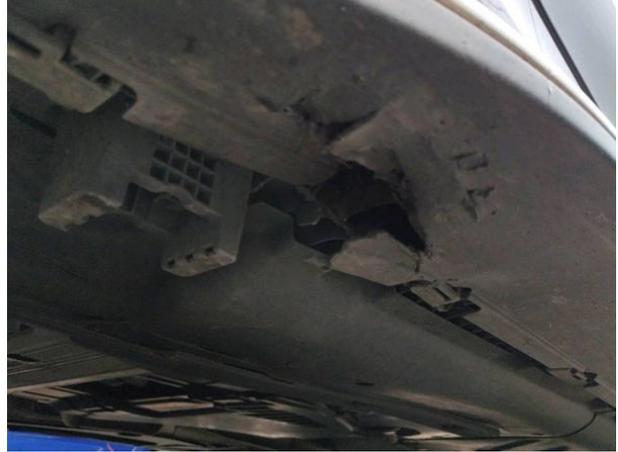
Slika R06: Prag levi

Slika R06-1: Počeno

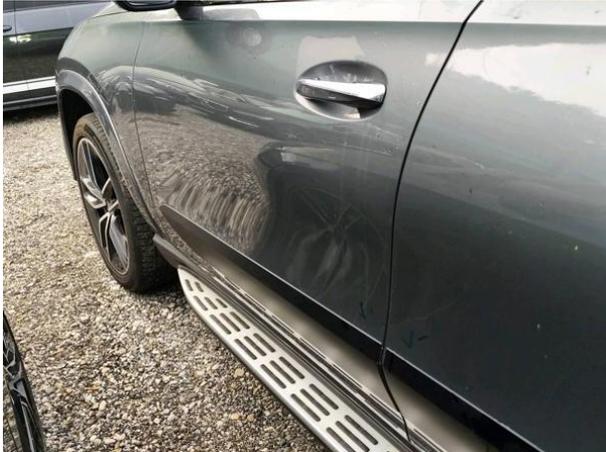
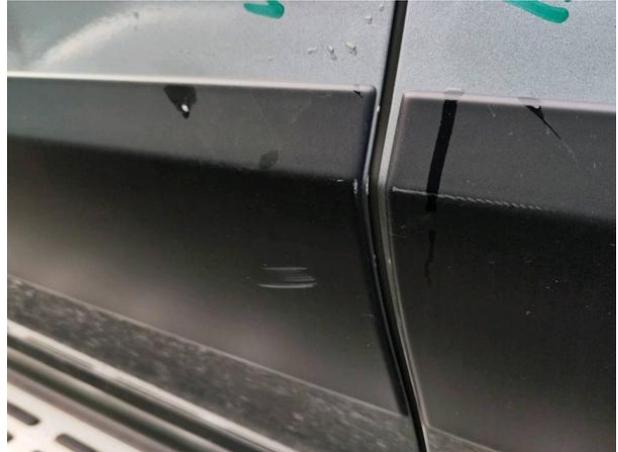
Slika R07: Sprednja vrata leva

Slika R07-1: Poškodba

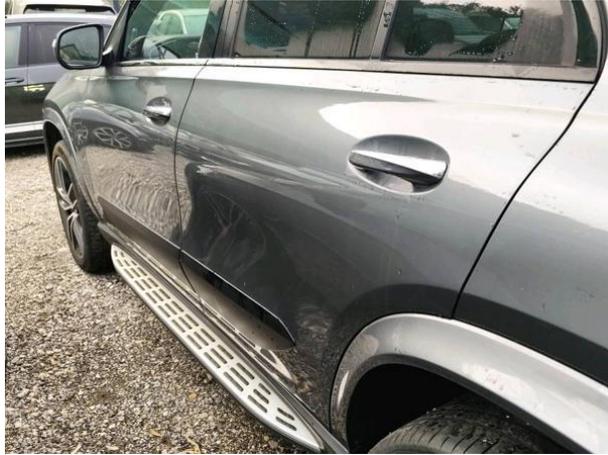
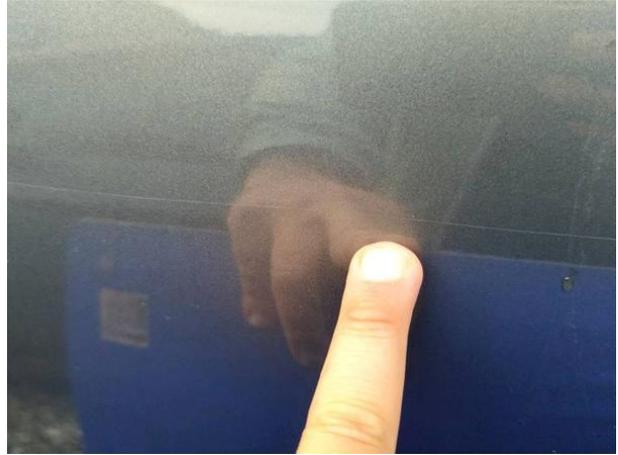
Slika R08: Zadnja vrata leva

Slika R08-1: Poškodba laka

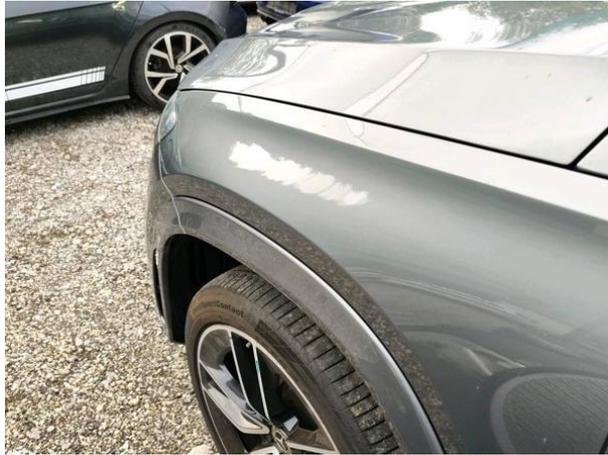
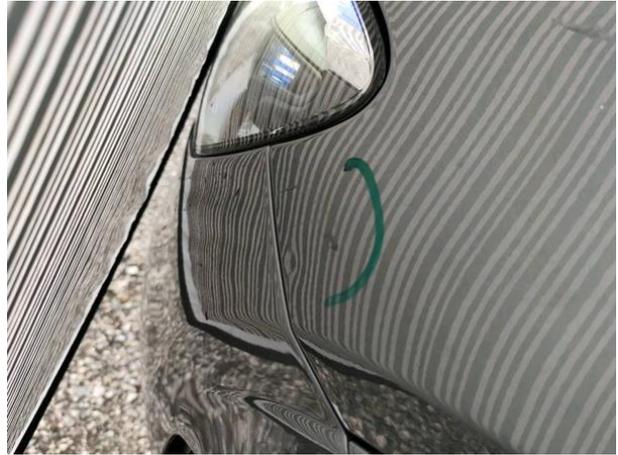
Slika R09: Blatnik levi

Slika R09-1: Vdolbina

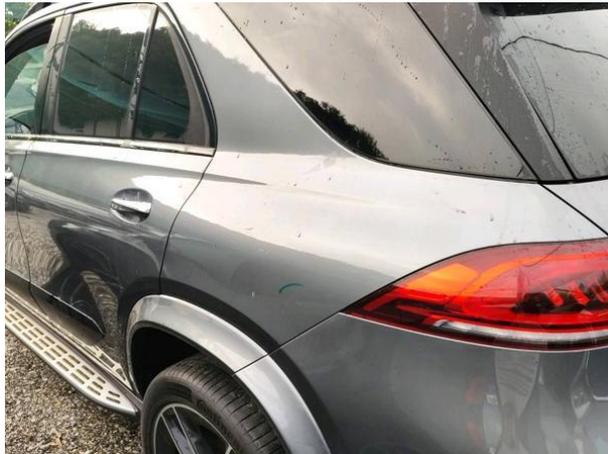
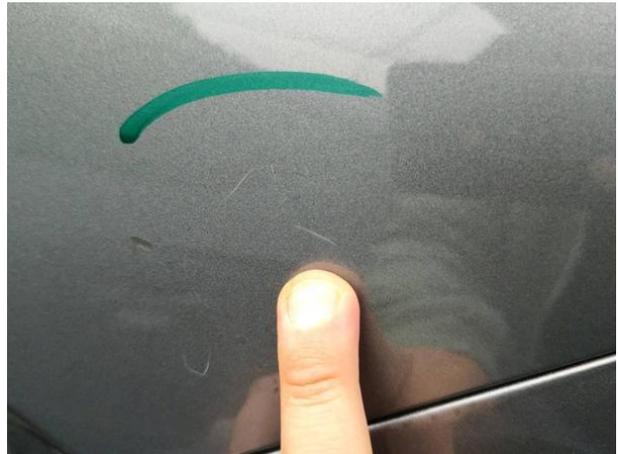
Slika R10: Stranica leva

Slika R10-1: Poškodba

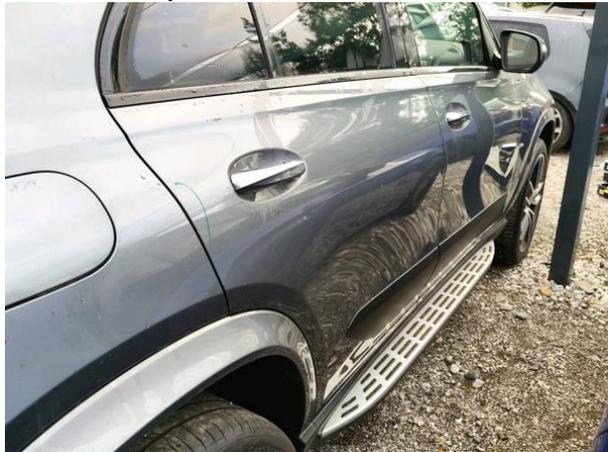
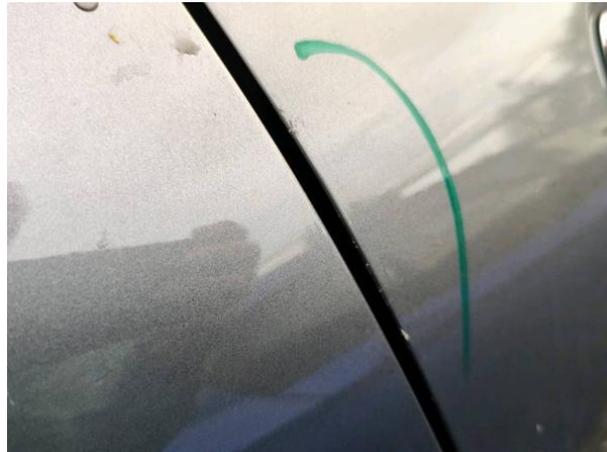
Slika R11: Zadnja vrata desna

Slika R11-1: Poškodba

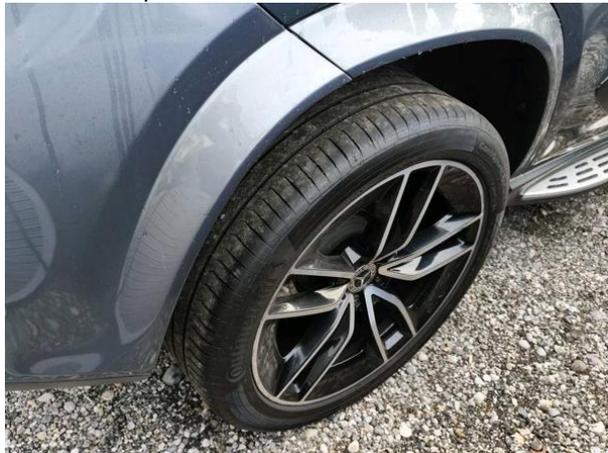
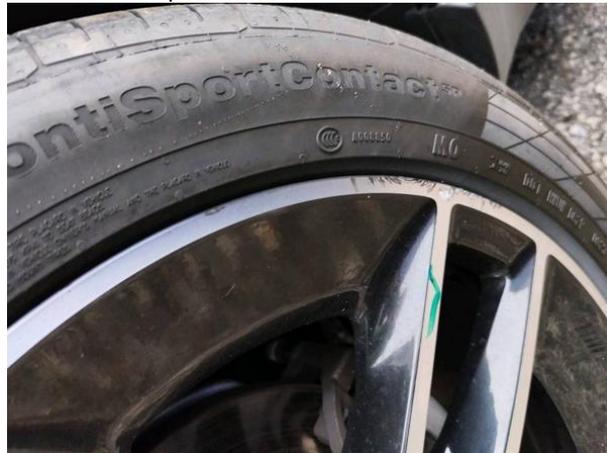
Slika R12: Al platišče

Slika R12-1: Popraskano

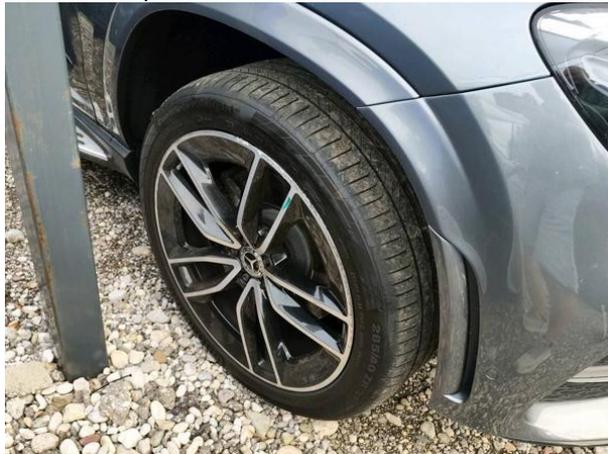
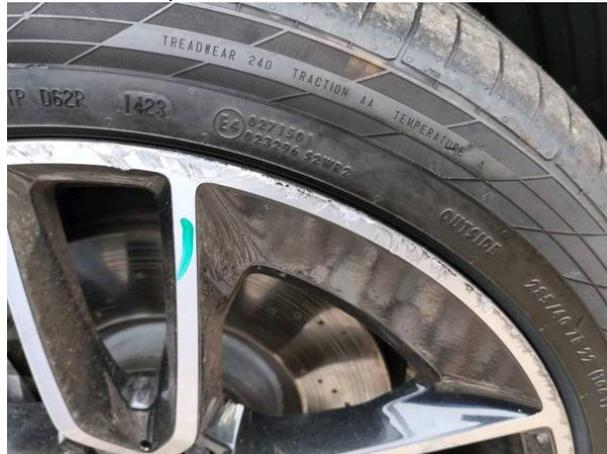
Slika R13: Al platišče

Slika R13-1: Popraskano

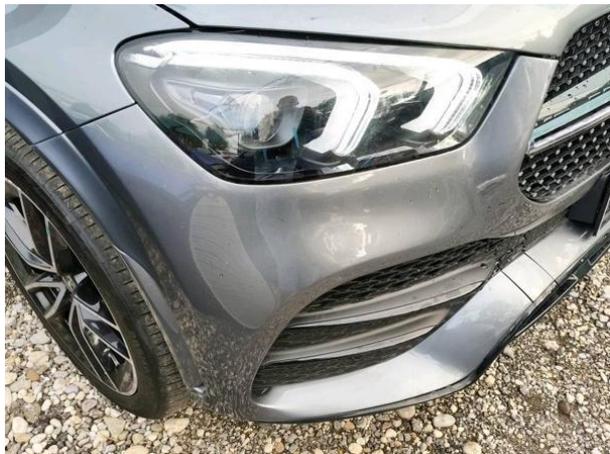
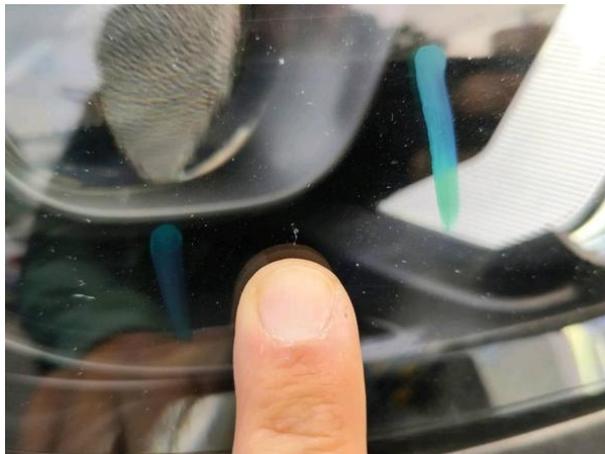
Slika R14: Žaromet

Slika R14-1: Poškodba

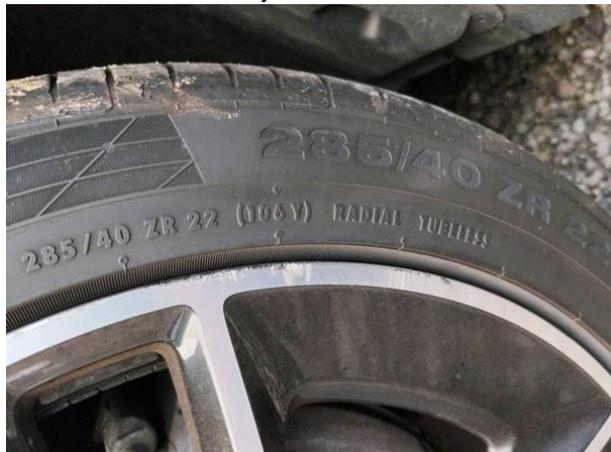
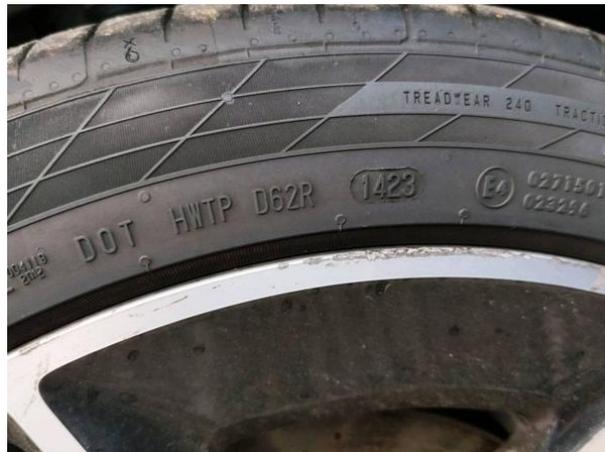
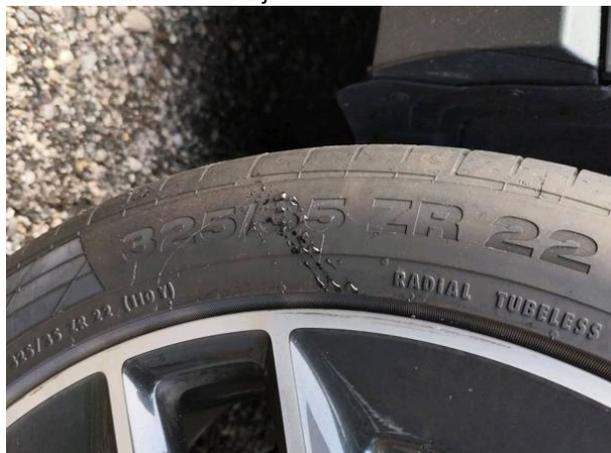
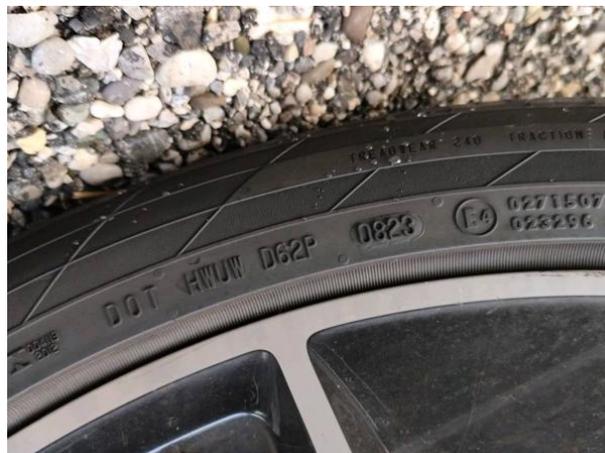
Pnevmatike so dimenzijsko ustrezne, starostno primerne in z dovolj profila.

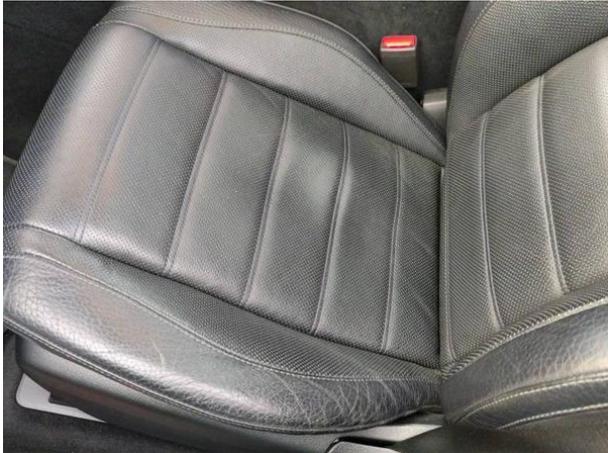
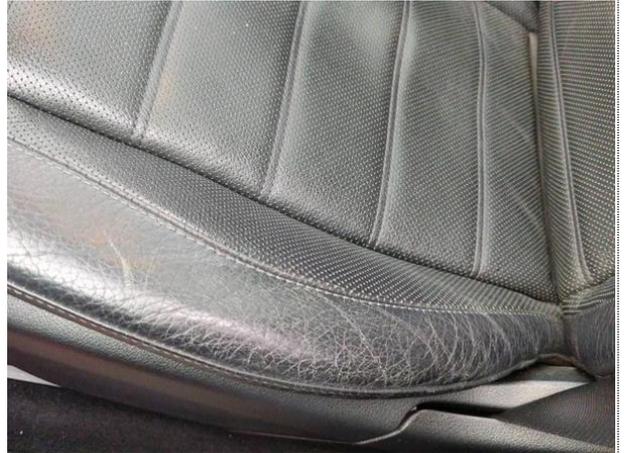
Slika N05: Sprednji levi sedež

- Sprednji levi sedež - poškodba
- Sprednji desni sedež - poškodba
- Obloga notranja - poškodba

Slika N05-1: Poškodba

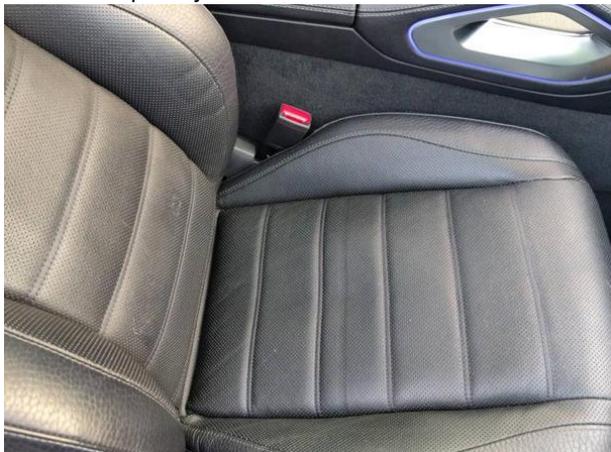
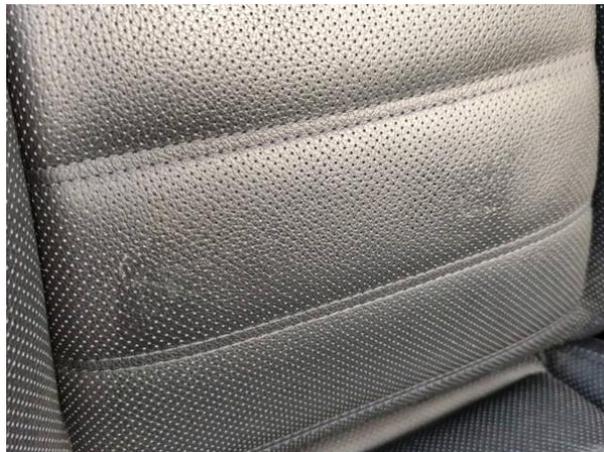
Slika N06: Sprednji desni sedež

Slika N06-1: Poškodba

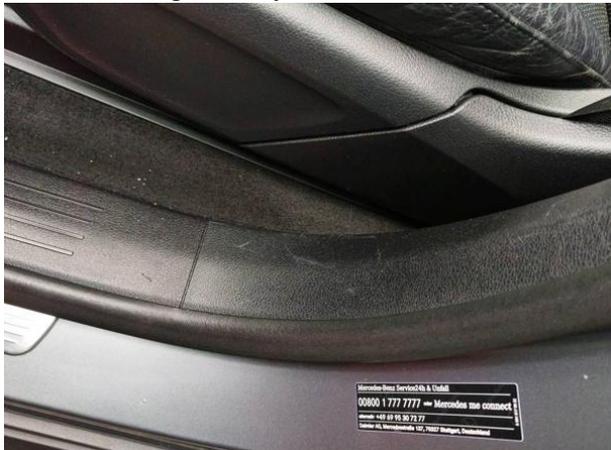
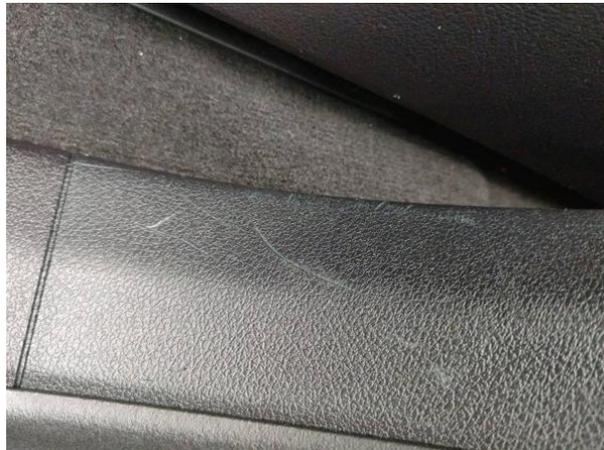
Slika N07: Obloga notranja

Slika N07-1: Poškodba
