CENILNO POROČILO

OSEBNI AVTOMOBIL (M1)

BMW IX XDRIVE AUT

VIN: **WBY11CF080CJ50722**

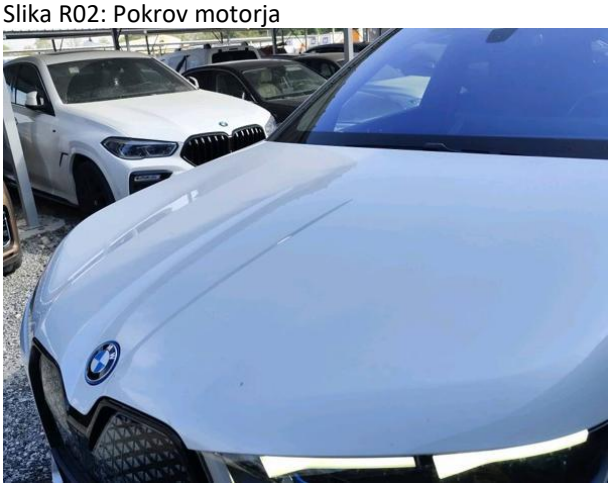
Na vozilu je vidnih nekaj odrgnin in poškodb pločevine in odbijačev.
Te poškodbe znižujejo tržno vrednost tega rabljenega vozila.
Opažene poškodbe:

Slika R01-1: Manjka
Slika R02-1: Vdolbina in poškodba laka
Slika R03-1: Poškodba laka
Slika R04-1: Poškodba
Slika R05-1: Popraskano
Slika R06-1: Poškodba laka
Slika R07-1: Poškodba
Slika R08-1: Poškodba laka
Slika R09-1: Poškodba
Slika R10-1: Poškodba laka
Slika R11-1: Popraskano
Slika R12-1: Poškodba laka
Slika R13-1: Poškodba laka
Slika R14-1: Poškodba laka
Slika R15-1: Popraskano
Slika R16-1: Poškodba
Slika R17-1: Poškodba
Slika R18-1: Poškodba
Slika R19-1: Popraskano
Slika R20-1: Poškodba

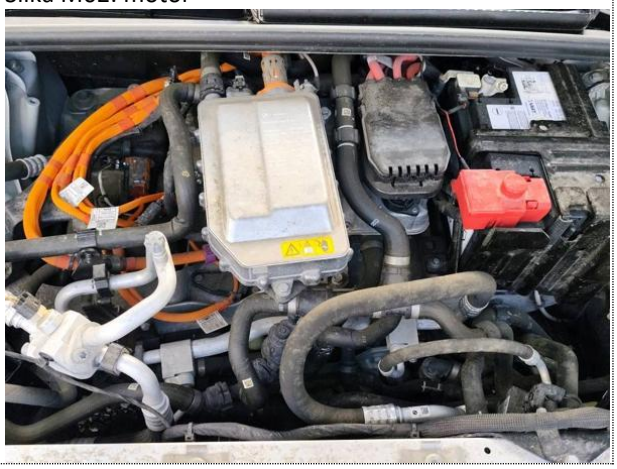
Zadnji servis opravljen 03.10.2024 pri 88592 km, glede na servisni interval ni potrebno opraviti servisa.

<u>Kmalu je potrebno opraviti servisni pregled.</u>
