AMZS d.o.o.
Cenitve in ostali pregledi vozil
Dunajska 128a
1000 Ljubljana

CENILNO POROČILO

OSEBNI AVTOMOBIL (M1)
VOLKSWAGEN ARTEON 2.0 TSI 4M AUT
VIN: **WVWZZZ3HZNE504776**

Ljubljana, 16.03.2026

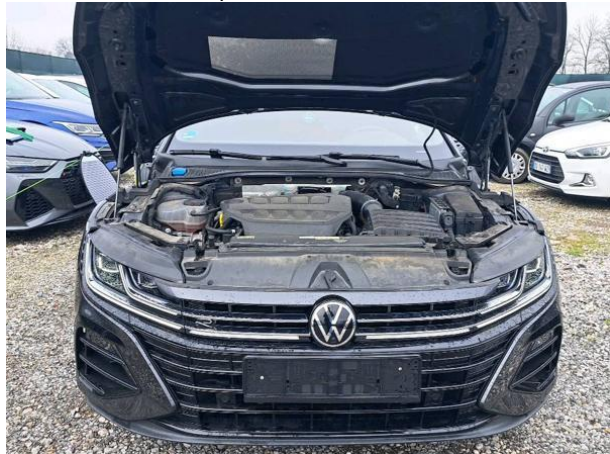
Slika M01: motorni prostor

Glede na servisni interval je potrebno opraviti servis.

Ob priklopu na diagnostično orodje so bile ugotovljene napake.
