CENILNO POROČILO

OSEBNI AVTOMOBIL (M1)
VOLVO XC 60 / 2.0 / TD AUT. AWD
VIN: YV1UZA8BCJ1003740

Ljubljana, 16.02.2026

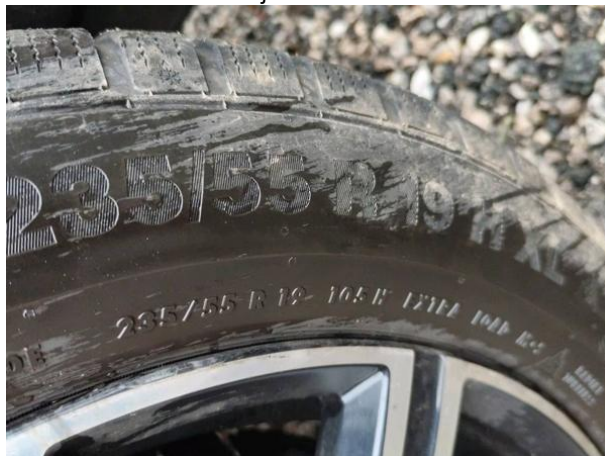
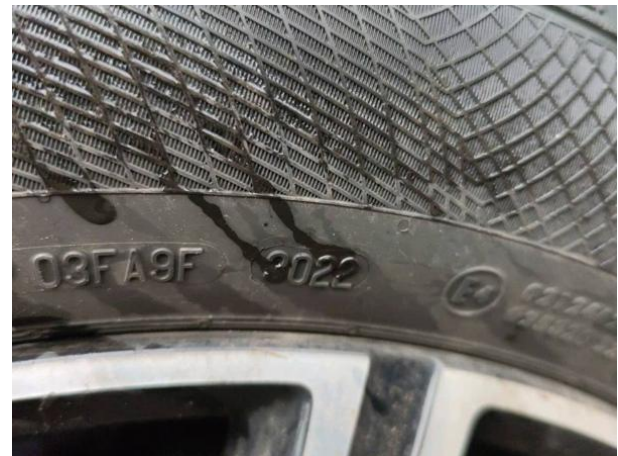
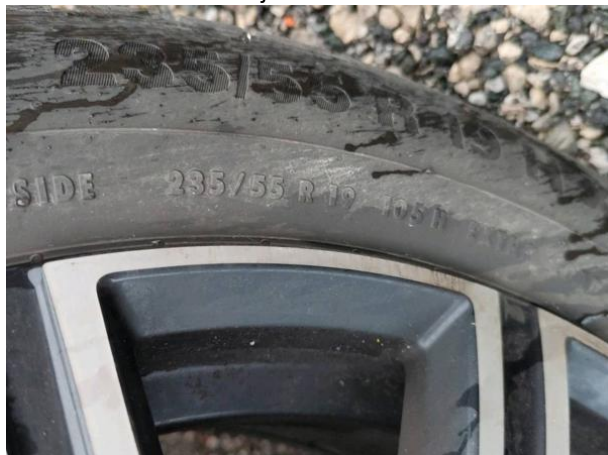
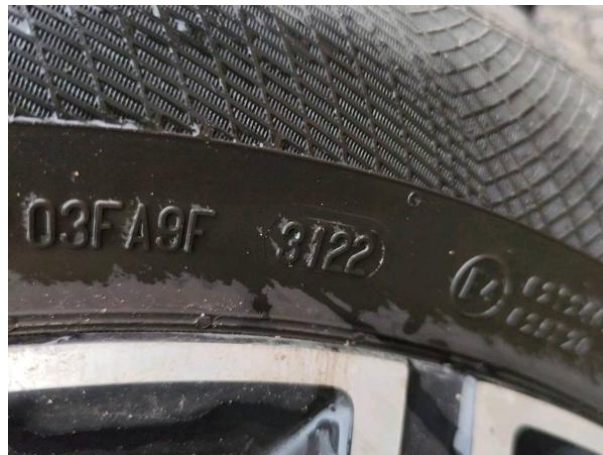
Lega	Znamka in tip	Vrsta	Dimenzija	Starost	Globina profila
1. os	continental wintercontact	zimske	235/55/19	DOT 30/22	5
2. os	continental wintercontact	zimske	235/55/19	DOT 30/22	5

Pnevmatike so dimenzijsko ustrezne, starostno primerne in z dovolj profila.

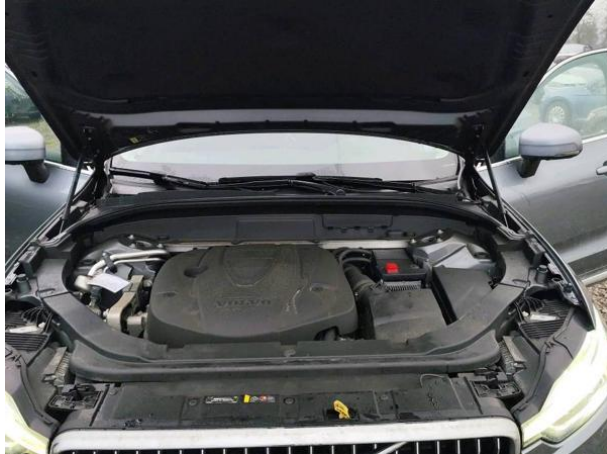
Slika M01: motorni prostor

Ob priklopu na diagnostično orodje so bile ugotovljene napake.
