AMZS d.o.o.
Cenitve in ostali pregledi vozil
Dunajska 128a
1000 Ljubljana

CENILNO POROČILO

OSEBNO AVTOMOBIL M1G
MERCEDES BENZ GLE / 300 / d 4-MATIC AUT.
VIN: WDC1671191A060715

Ljubljana, 17.09.2025

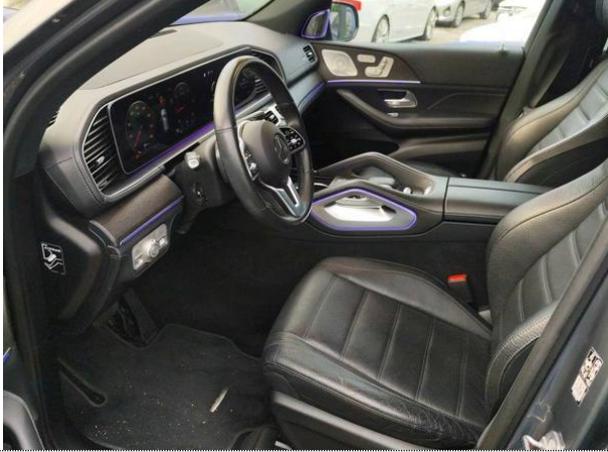
Slika N01: spredaj levo

- Sprednji levi sedež - poškodba
- Sprednji desni sedež - poškodba
- Obloga notranja - poškodba

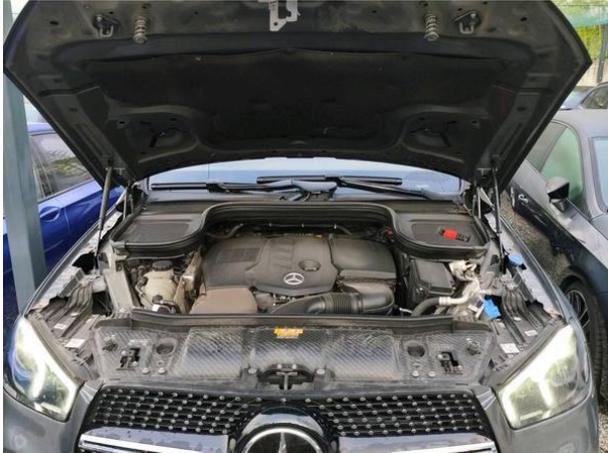
Slika M01: motorni prostor

Ob priklopu na diagnostično orodje so bile ugotovljene napake.
